Monitoring Cruise at the Saco Bay
Disposal Site, May 1990

ARMY.NE.DAMOS
Contrib. No. 81

1. AGENCY USE ONLY (Leave blank)		2. REPORT DATE April 1991	3. REPORT TYPE AND DATES COVERED Final Report		
4. TITLE AND SUBTITLE Monitoring Cruise at the Saco Bay Disposal Site, May 1990			5. FUNDING NUMBERS

Report No.
SAIC-90/7587&C88

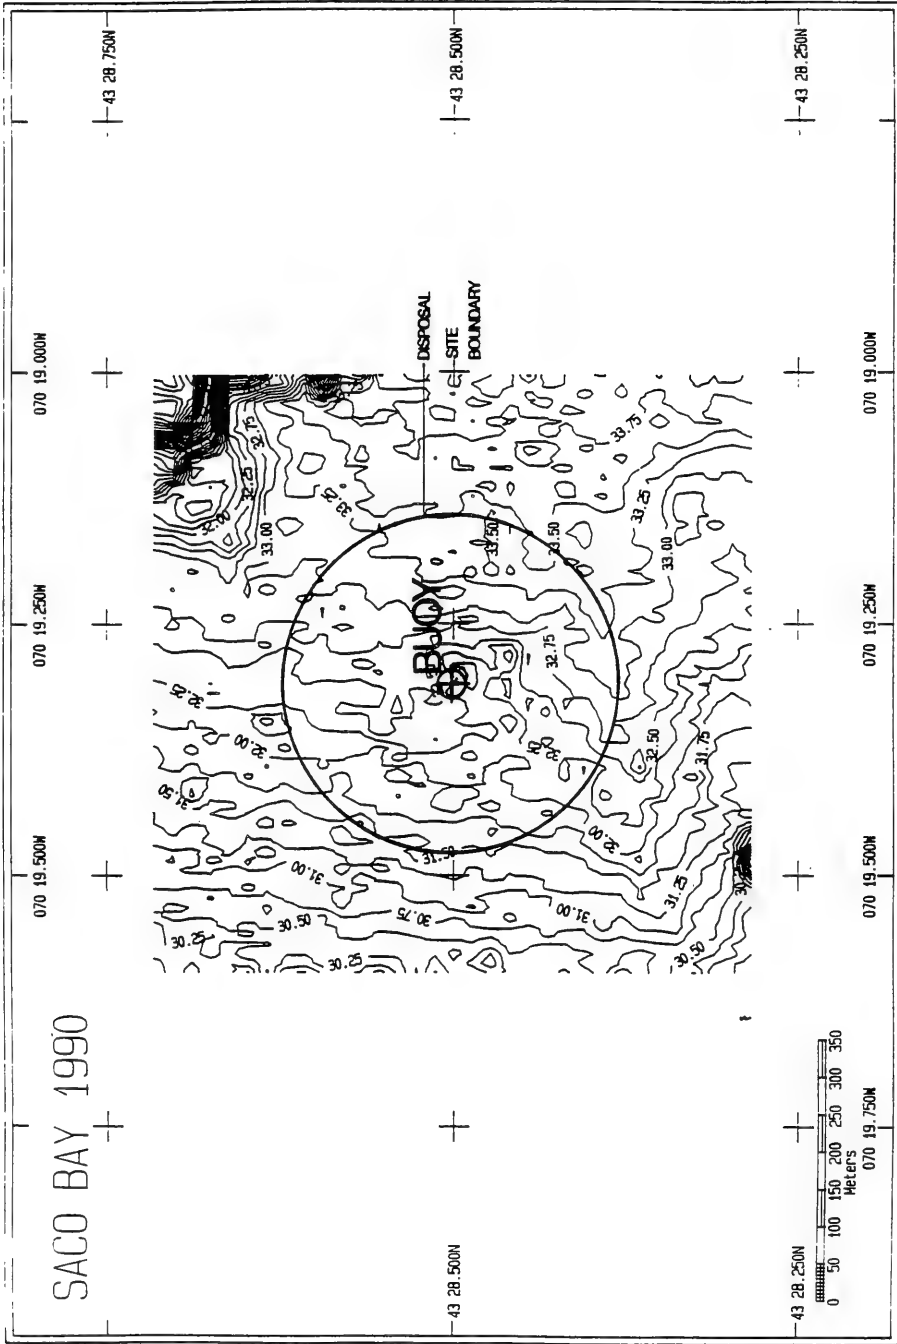
Figure 3-1. Bathymetric contour chart (800 X 800 m) of Saco Bay Disposal Site, May 1990.

Acoustic detection of dredged materials at the Saco Bay Disposal Site was hampered by the relatively low volume of material disposed, its apparently wide distribution over the site, and the lack of a pre-disposal survey. Although the bathymetric survey did not detect a single, distinct mound, there were several features that probably represented the results of dredged material disposal. A potential disposal feature was present in the region between the 32.0 m and 32.5 m contours, just west of the survey center and tending toward the southwest (Figure 3-1). An enlargement of this region revealed three small peaks (A, B, C) elevated approximately 0.5 m above the surrounding topography, and between 25 to 60 m in diameter (Figure 3-2). The area encompassing peaks A, B, and C was approximately 11,940 m² and roughly 150 m in diameter. Water depths across the site deepened progressively towards the east and away from shore (Figure 3-1). The shallow feature at the extreme northeast corner of the survey was part of the natural bottom topography and unrelated to disposal activities.

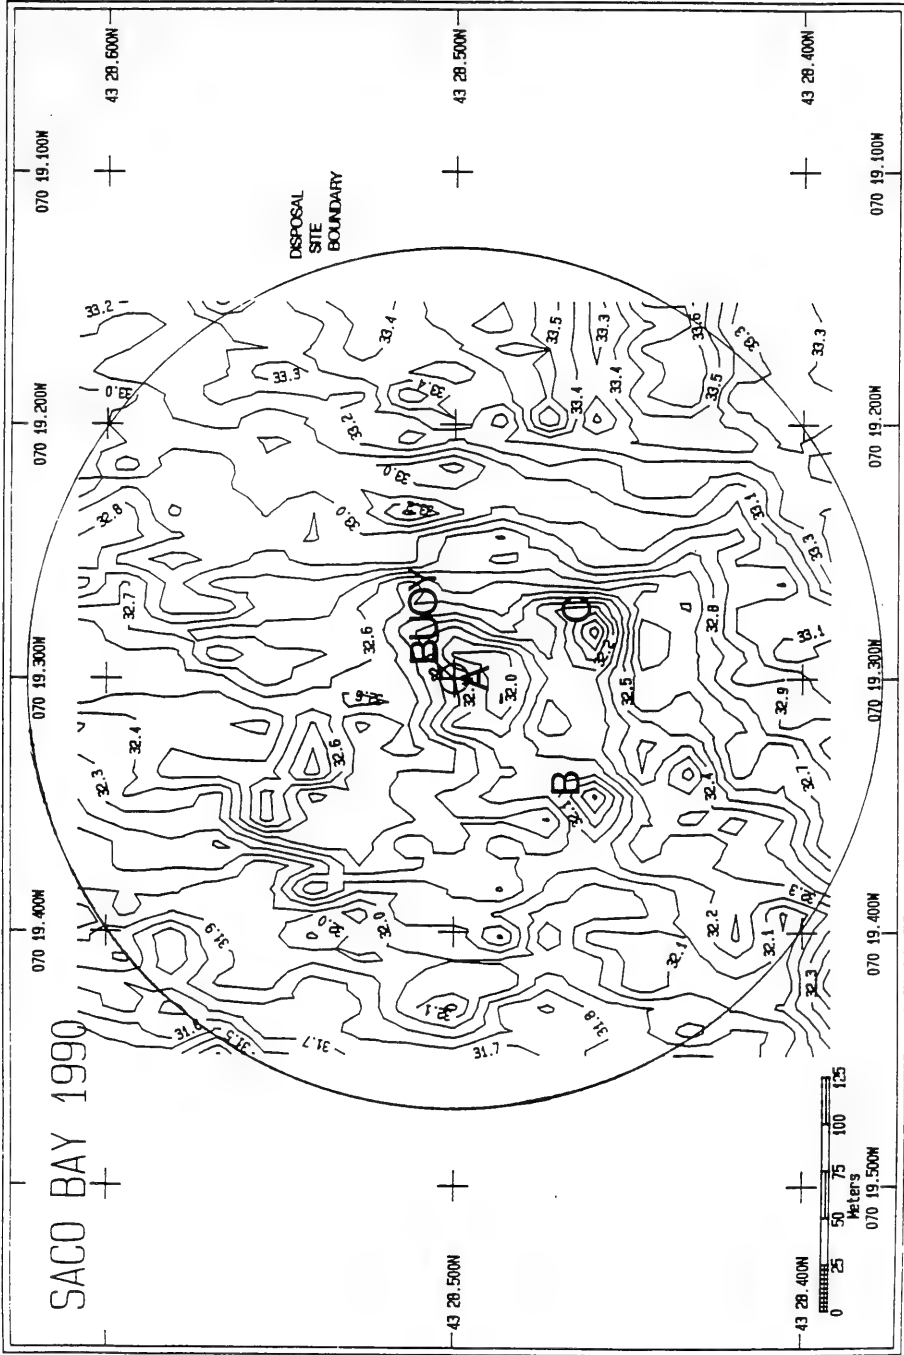
Figure 3-2. Detail of bathymetric contour chart (400 X 400 m) of Saco Bay Disposal Site, May 1990. A, B, C mark three small mounds.

Although the bathymetric survey did not show clear evidence of a distinct mound, the central region of the site contained three small features that were probably the result of disposal activities (Figure 3-2). These areas projected only about half a meter above the surrounding topography and fell within the bounds of dredged material mapped by REMOTS®. The region encompassing all 3 rises was about 150 m in diameter, covering an area of approximately 11,940 m². Dredged material in REMOTS® photographs extended across an area at least 76,700 m² in the central and southern parts of the survey (Figure 3-3). The mound height was most likely overestimated by the capping model (2 m) because disposal of dredged material was apparently spread across the site (Figure 3-2), rather than in a tightly controlled area close to the buoy. Furthermore, without pre-disposal bathymetric data, accurate verification of the model height and radius predictions was not possible.
